Re: July 2016 Monthly Progress Report
Administrative Settlement Agreement and Order on Consent for Removal Action
U.S. EPA Region 10 Docket No. CERCLA 10-2009-0255
Gasco Sediments Site within the Portland Harbor Superfund Site

Attachment A Monthly Visual Monitoring Report for Pilot Cap Vicinity

Visual Observations Log Form

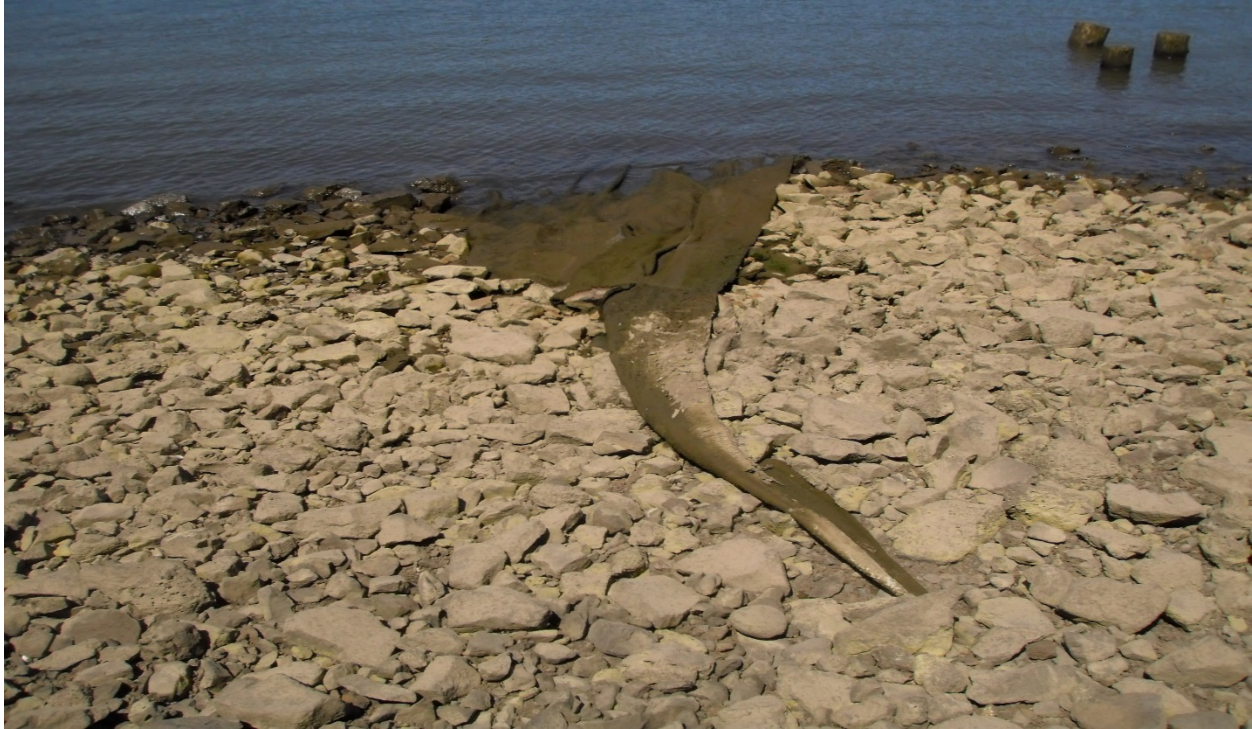
Observations of Erosion/Deposition: No erosion/deposition was evident along the shoreline. All previously noted organo-clay mat material segments are visible. A segment 5 feet in length is out of the water approximately 6 feet from the water's edge, near the lateral mid-point of the cap area. A 15-foot section is shoreward of the water's edge, perpendicular to the shoreline at the upriver boundary of the cap area (Photo 1). A section of organo-clay mat material measuring 40 feet in length is exposed near the downriver extent of the cap at the water's edge.

Photo 1 — *Mat material visible at the upriver extent of the cap area. (7/25/16):*

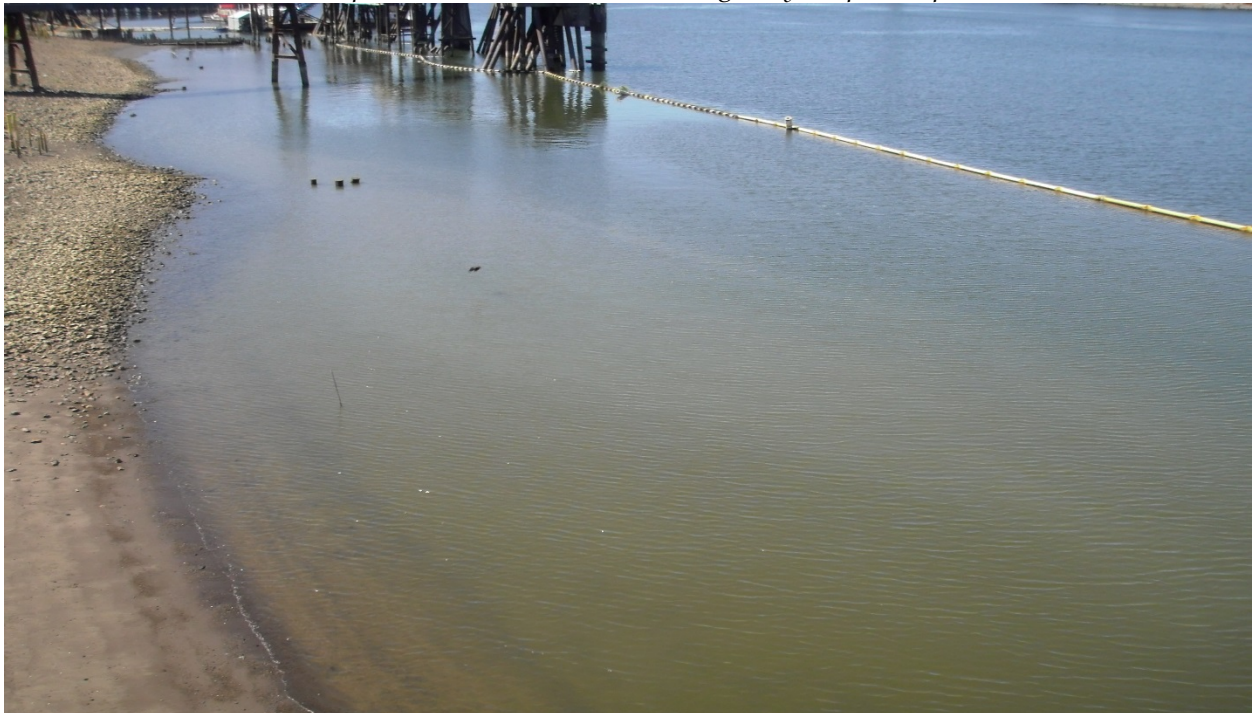
Observations of Long-term Controls (i.e., oil booms, organo-clay mat, etc.) During the observation, the FAMM containment boom was in place across the cap area from the ship dock to an anchor point riverward of the upriver dolphin. Two buoys that identify the cap area to mariners were in place as installed. The position of the FAMM oil boom and warning buoys is shown in Photo 2.

Photo 2 — *FAMM oil boom placement and mariner warning buoys at pilot cap area. (7/25/16):*

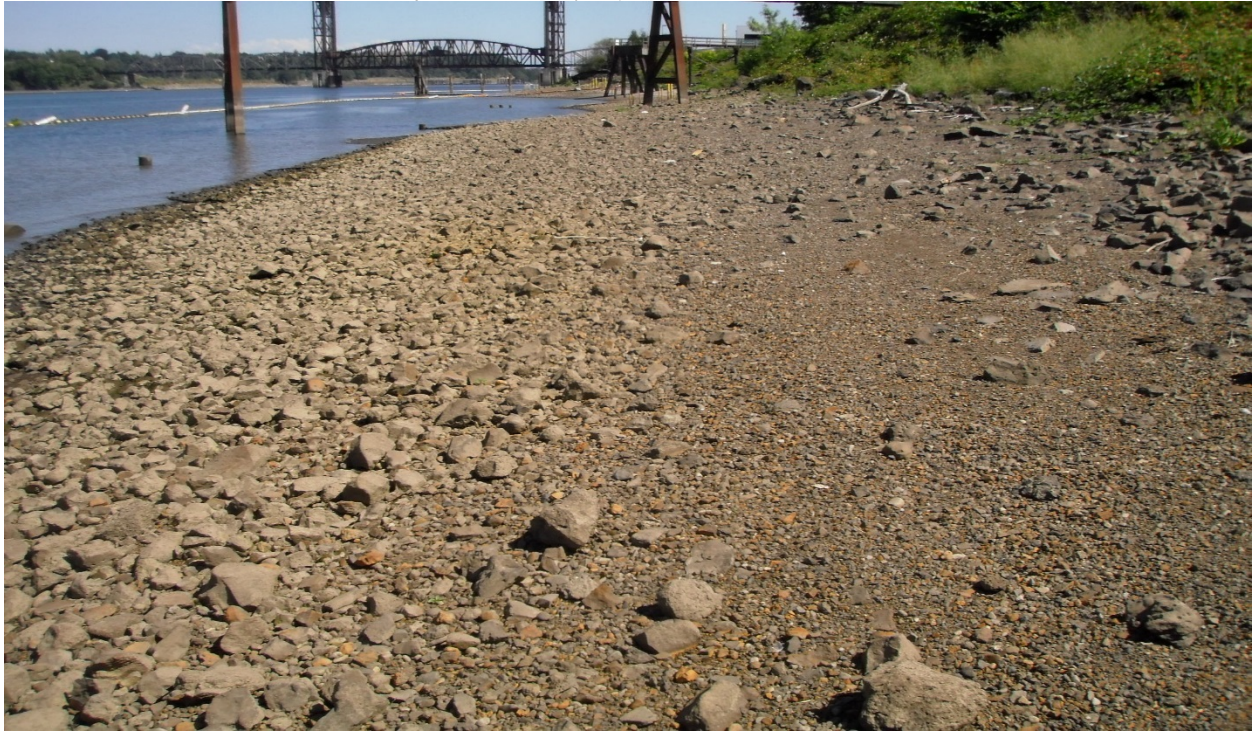
No sheen was evident in or around the cap area. Photo 3 shows the water surface and shoreline immediately downriver of the sediment cap.

Photo 3 — *Conditions immediately downriver of cap area (7/25/16):*
